Smoke and Dye Testing Summary

High Level Sewershed

Test ID	Test Type	Date Inspected	Company / Super.	Blower MH	Ground Condition	Notification Made?	Total Length
S1028-262	Smoke	9/1/2009	ADS/TM	S21KK_016MH	Dry	Yes	955.93

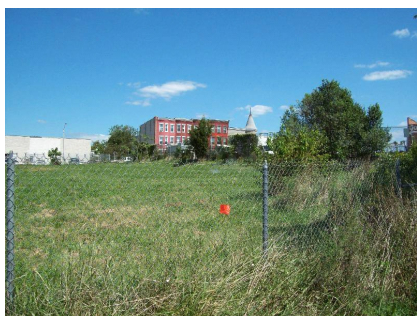
Obs_ID S1028-262-OB01

Source Service Lateral

Location Field / woods

Comments Smoke from service lateral in open field near brake shop. 2614 Pennsylvania Ave.

Comments Back of lot, 2614 Pennsylvania Ave.

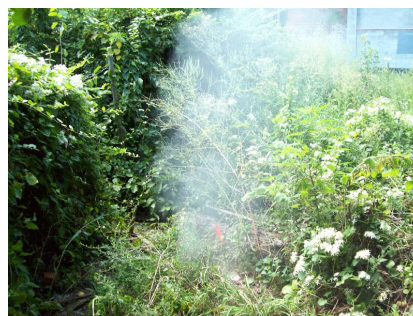
Obs_ID S1028-262-OB02

Source Cleanout

Location Yard - back

Comments Smoke from cleanout in back yard. 1607 Clifton Ave.

Comments Back of house, 1607 Clifton Ave.

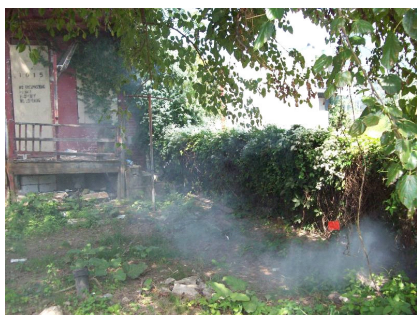
Obs_ID S1028-262-OB03

Source Service Lateral

Location Yard - back

Comments Smoke from service lateral in back yard. 1615 Clifton Ave.

Comments Back of house, 1615 Clifton Ave.

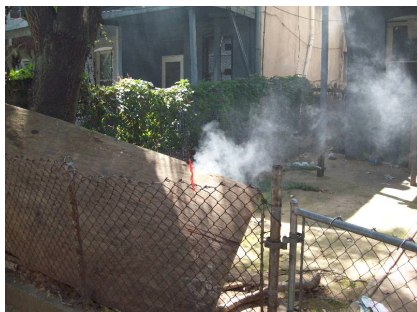
Obs_ID S1028-262-OB05

Source Cleanout

Location Paved concrete

Comments Smoke from cleanout in paved concrete behind house. 2039 Fulton Ave.

Comments Back of house, 2039 Fulton Ave.

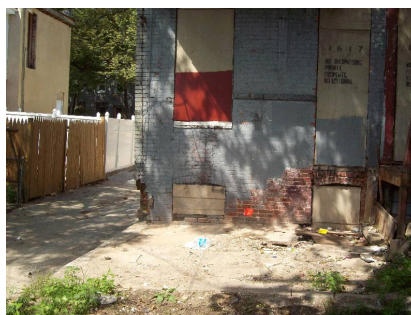
Obs_ID S1028-262-OB04

Source Building Interior

Comments Smoke from building interior. 1617 Clifton Ave.

Comments Back of house, 1617 Clifton Ave.

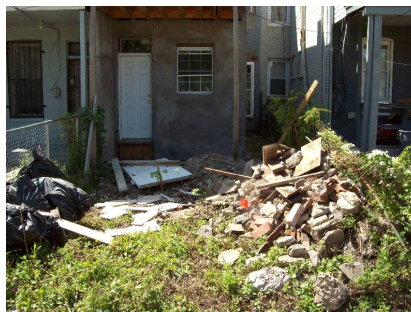
Obs_ID S1028-262-OB06

Source Cleanout

Location Yard - back

Comments Smoke from cleanout in back yard. 2021 Fulton Ave.

Comments Back of house, 2021 Fulton Ave.

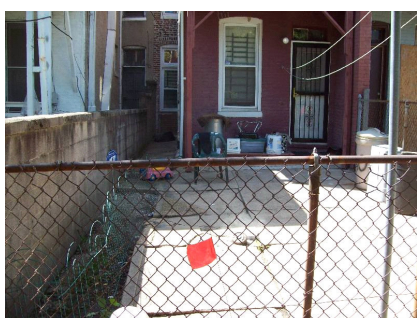
Obs_ID S1028-262-OB07

Source Cleanout

Location Paved concrete

Comments Smoke from cleanout in paved concrete behind house. 2015 Fulton Ave.

Comments Back of house, 2015 Fulton Ave.
